# Application form

## Development by the State

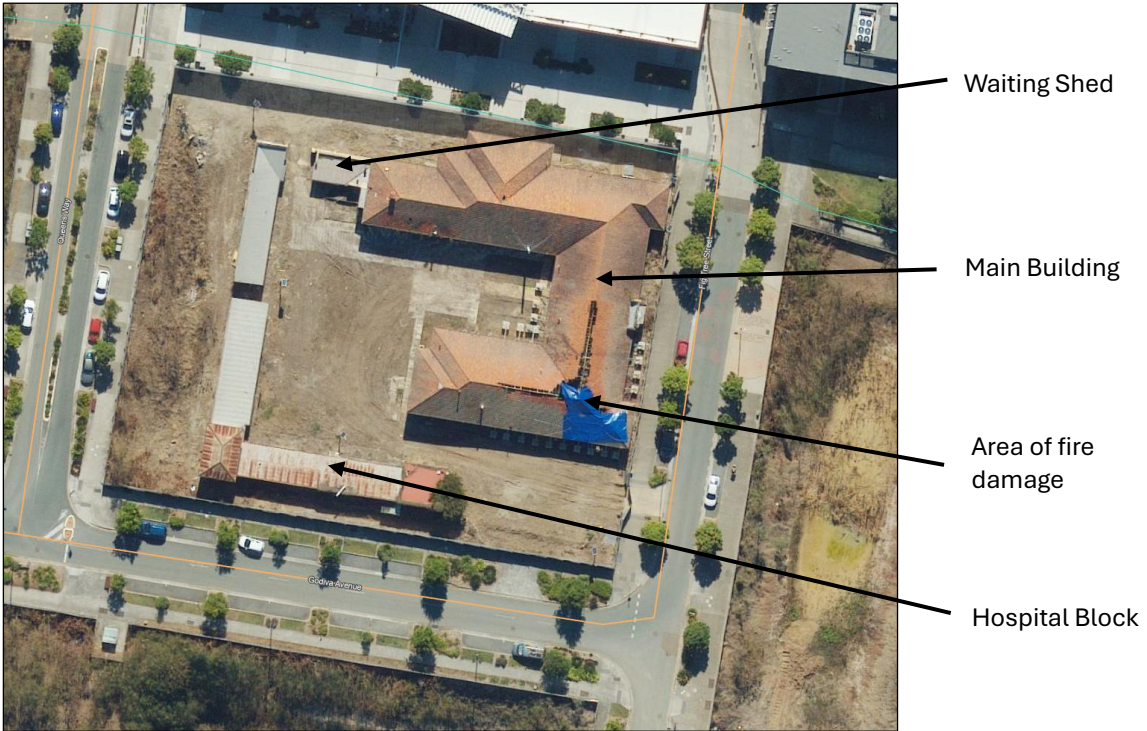
Image ES2. Aerial photograph showing location of fire damage to the roof (Source: Queensland Globe).

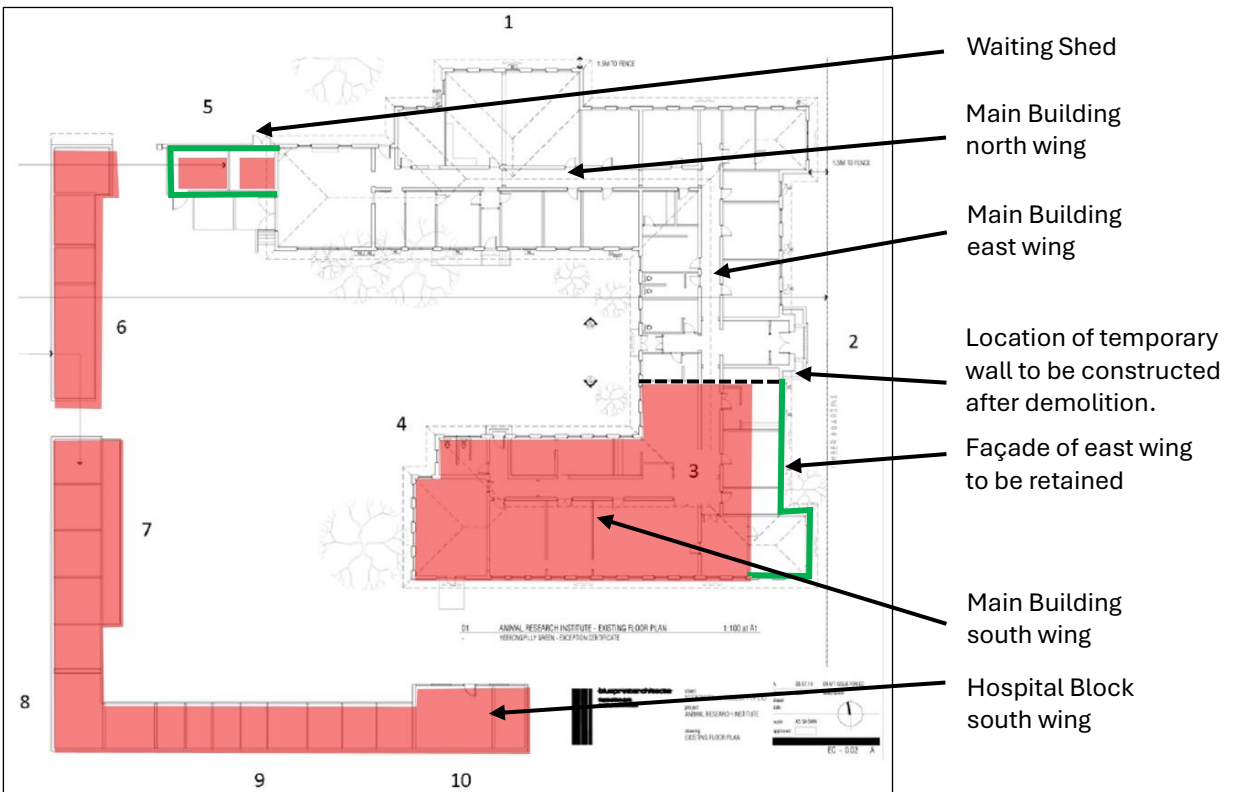
Image ES3. Diagrammatic site plan of proposed demolition works shaded in red, retained facades in green and temporary wall dotted (Source: Blueprint Architects from EDQ with shading by SAH).

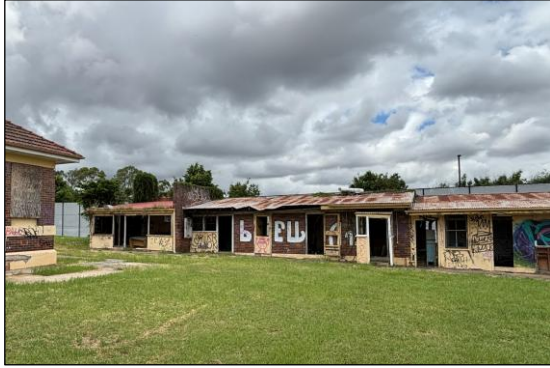
Image 3. South wing north elevation (Jan 26).

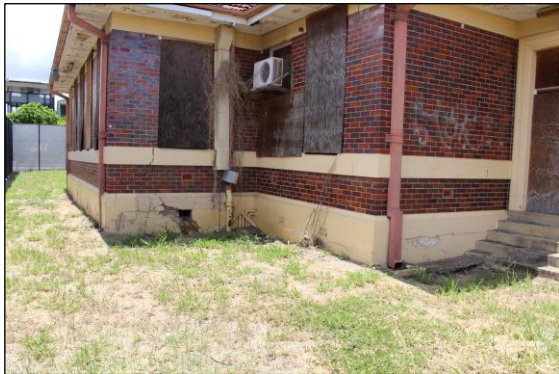
**Image 26. North wing part north elevation looking east showing substantial subfloor cracking (Jan 26).**

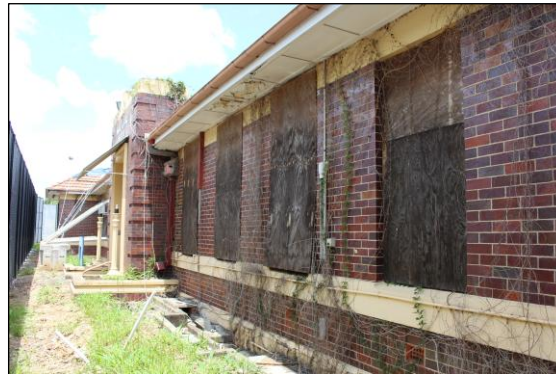
**Image 27. East elevation looking south (Jan 26).**

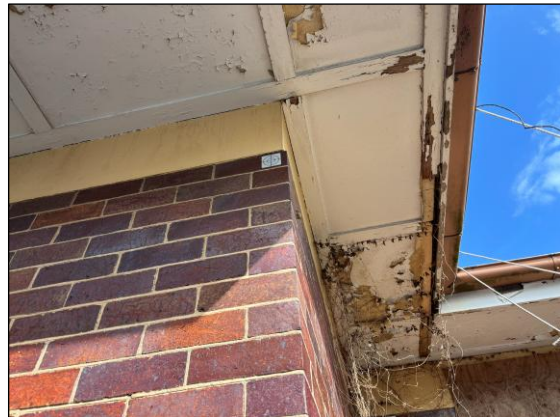
**Image 39. Water damage to eaves soffit (Apr 26).**

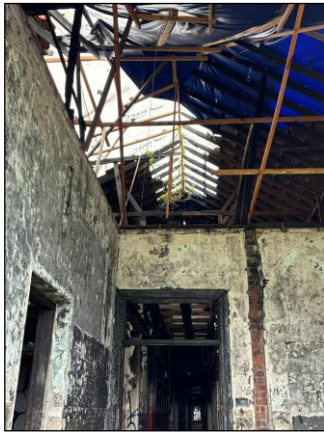
**Image 40. South wing fire damage viewed from an external window (Jan 26)**

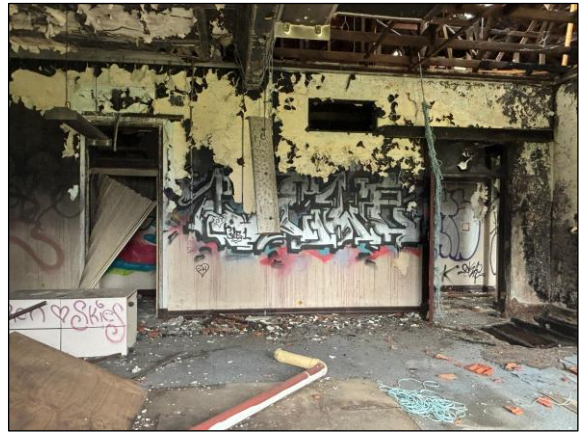
**Image 41. South wing fire damage viewed from an external window (Jan 26).**

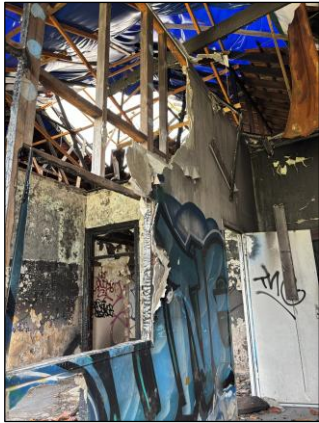
**Image 42. South wing fire damage viewed from an external window (Jan 26).**

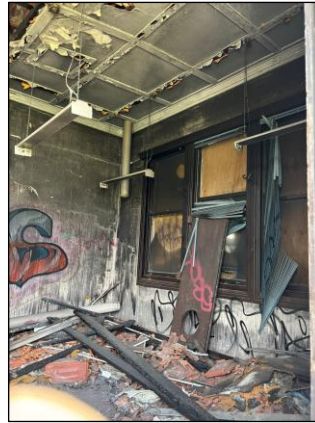
**Image 43. South wing fire damage viewed from an external window (Jan 26).**

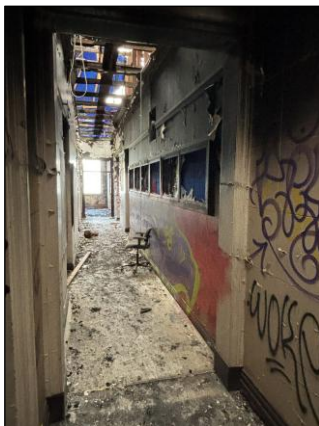
**Image 44. East wing central corridor looking south from entry into fire damaged area (Jan 26).**

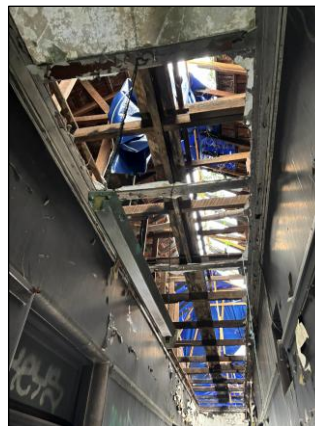
**Image 45. East wing central corridor looking south, sheeted ceiling damaged by fire (Apr 26).**

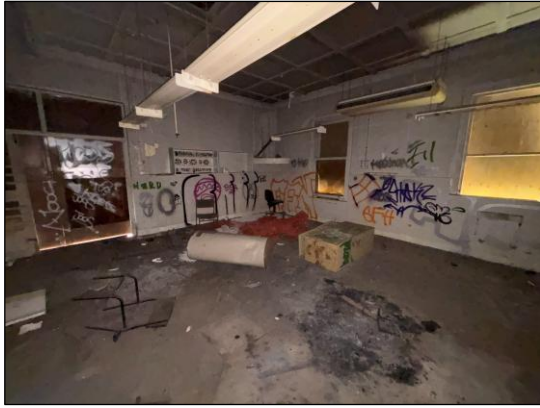
**Image 46. North wing operating theatre looking west (Jan 26).**

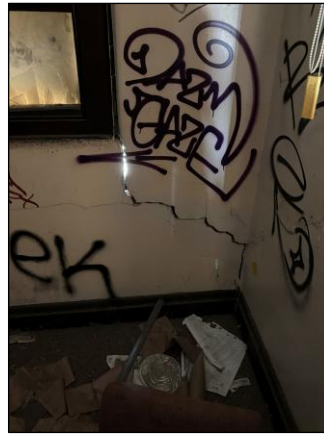
**Image 53. North wing meeting room, substantial cracking to external wall (Jan 26).**

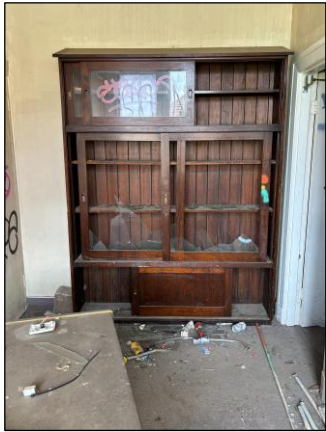
**Image 54. North wing example of fixed timber furniture to be retained (Jan 26).**

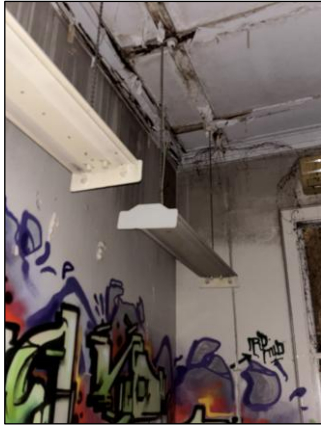
**Image 58. North wing south side damaged ceiling from water ingress (Jan 26).**

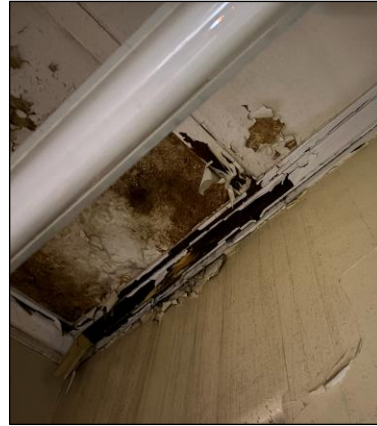
**Image 59. North wing damaged ceiling from water ingress showing original dark timber finish to timber cornice (Apr 26).**

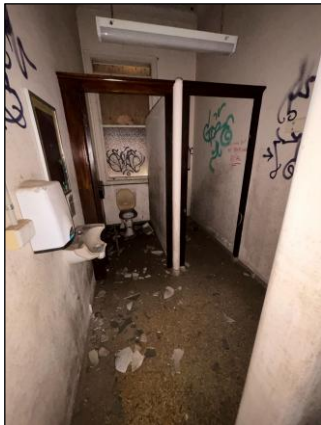
**Image 60. East wing toilets with terrazzo flooring, asbestos sheet wall lining and original door frames (Jan 26).**

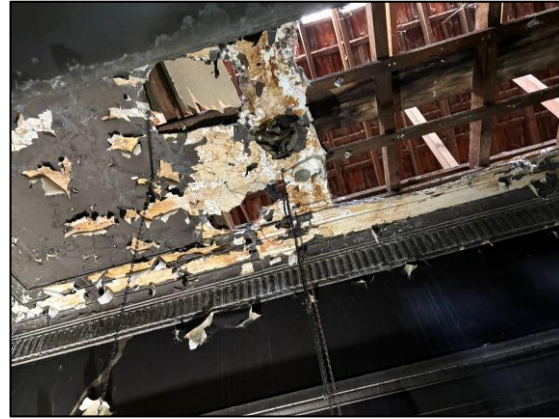
**Image 65. East wing entry showing fire damage to plaster ceiling to be removed, decorative cornice to be retained if possible (Apr 26).**

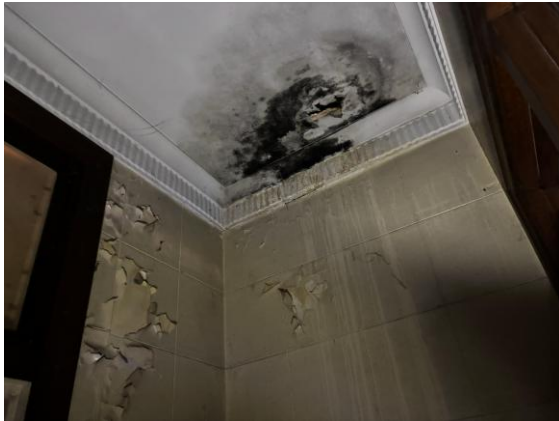
**Image 66. East wing entry water damage to plaster ceiling (Apr 26).**

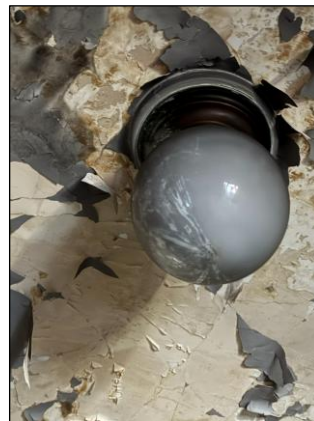
**Image 67. East wing entry original light fitting to be salvaged for reuse (Apr 26).**

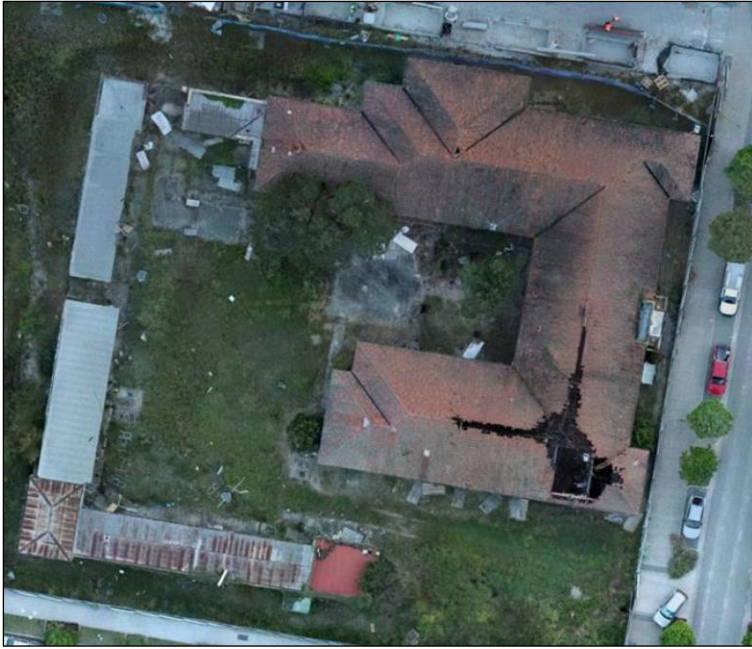
**Image 68. Aerial photograph (November 2023) showing extent of roof damage from fire prior to installations of tarpaulins (Source: Bligh Tanner 2024).**

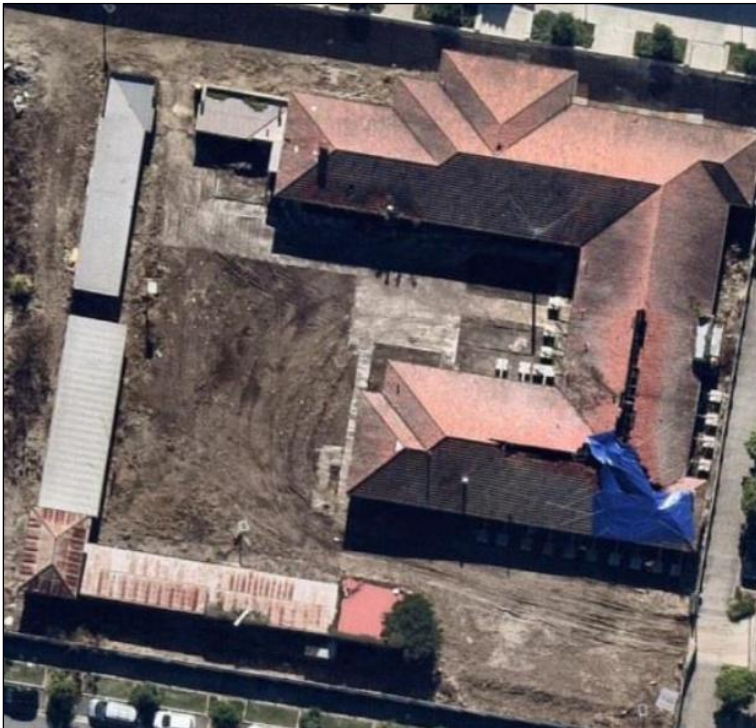
**Image 69. Aerial photograph (June 2024) (Source: Bligh Tanner 2023).**

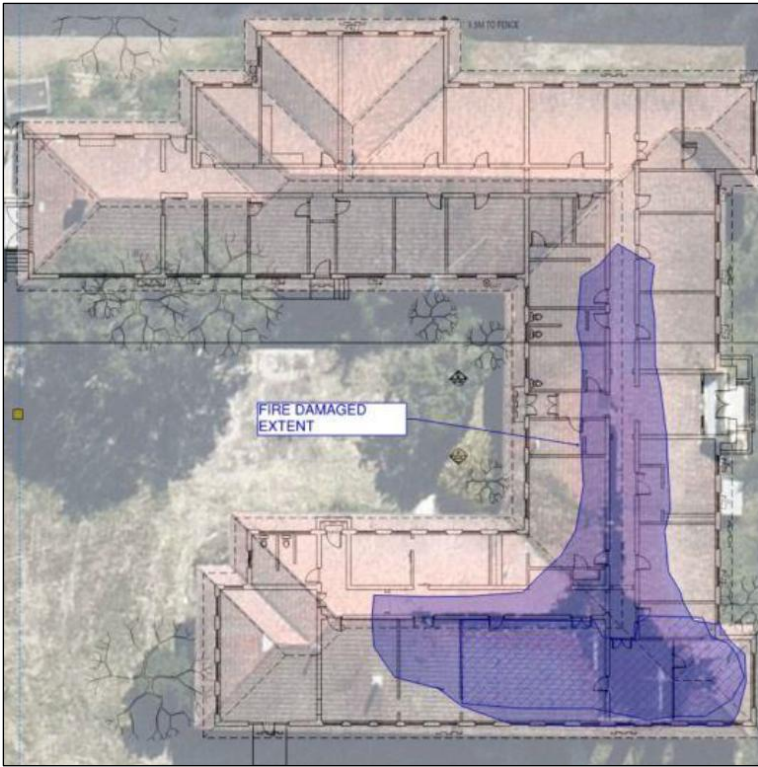
Image 70. Roof Plan showing extent of fire damage (Source: Bligh Tanner 2024).

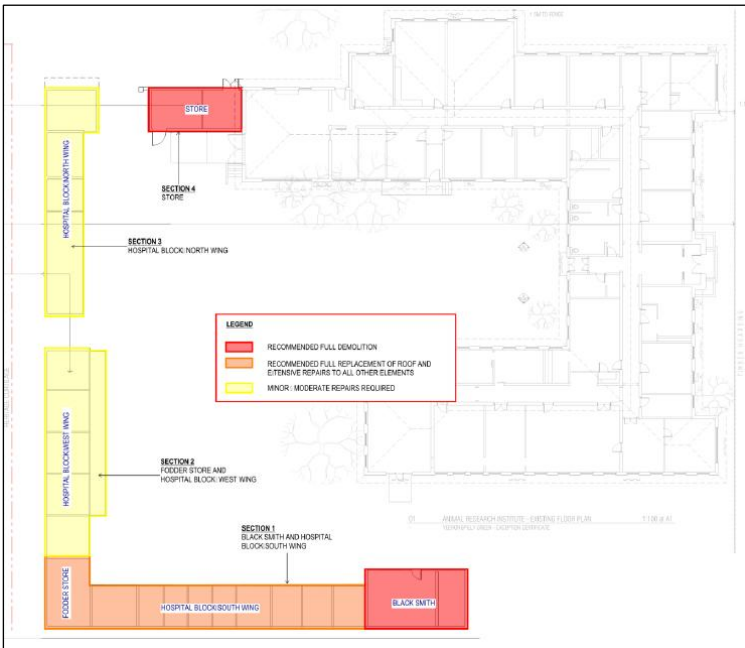
Image 71. Hospital Block condition survey (Source: Bligh Tanner 2024).

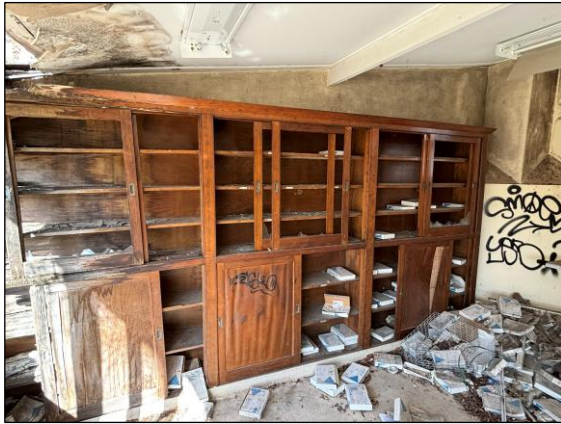
Image 72. Damaged built-in furniture (Apr 26).

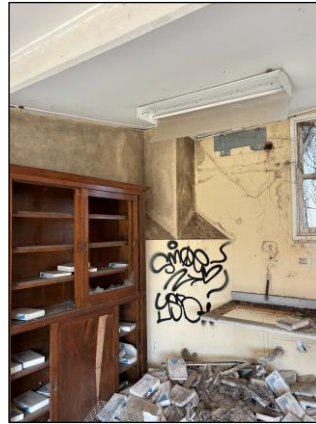
Image 73. Corner forge sheeted over (Apr 26).

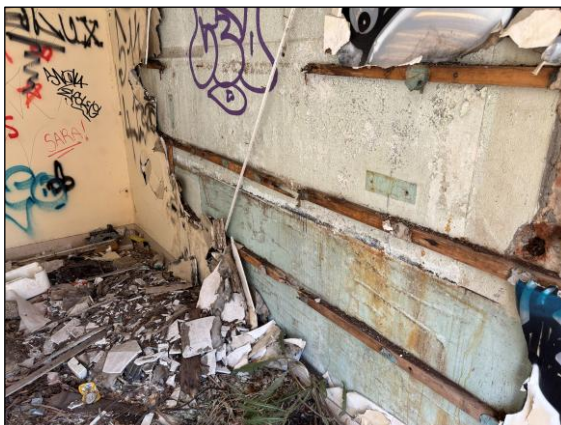
Image 76. Termite damage to wall framing (Apr 26).

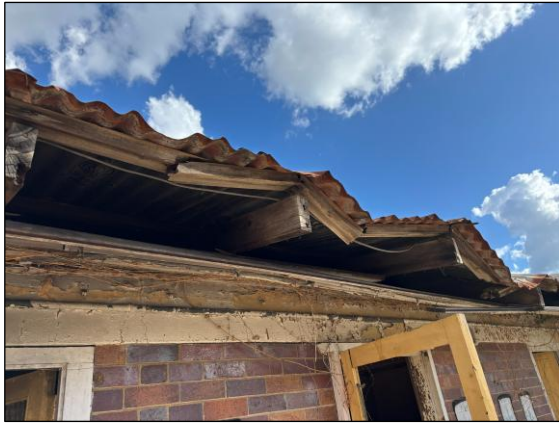
Image 77. Collapsing roof framing (Apr 26).

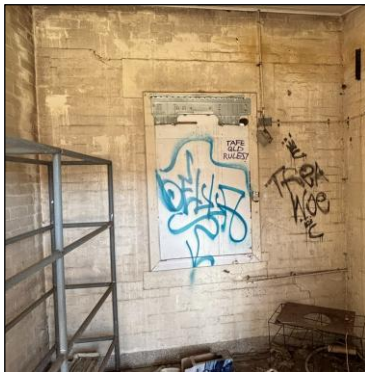
Image 79. Cracks in brickwork (Apr 26).

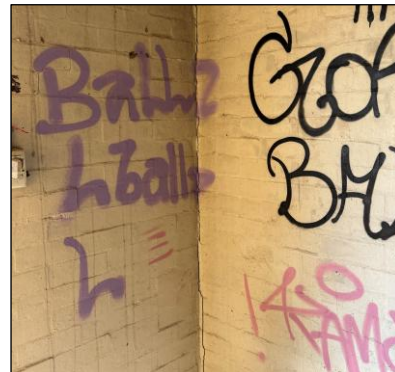
Image 80. Cracks in brickwork (Apr 26).

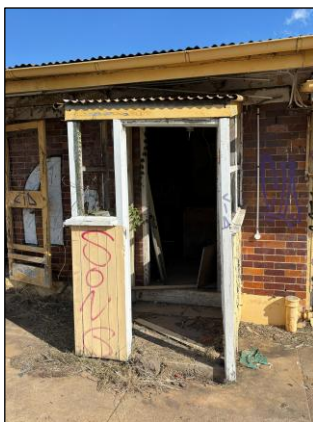
Image 81. Deteriorating timber entry (Apr 26).

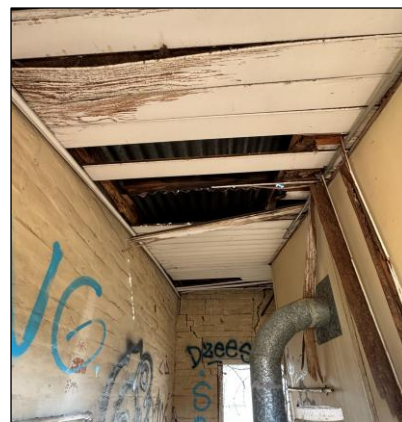
Image 82. Collapsing boarded ceiling and cracks in brickwork (Apr 26).

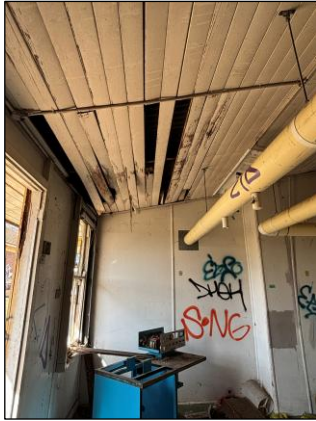
**Image 83. Collapsing boarded ceiling (Apr 26).**

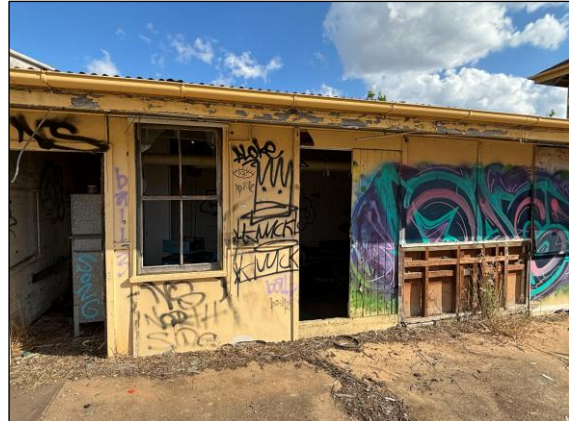
**Image 84. Broken asbestos sheet and termites in wall framing (Apr 26).**

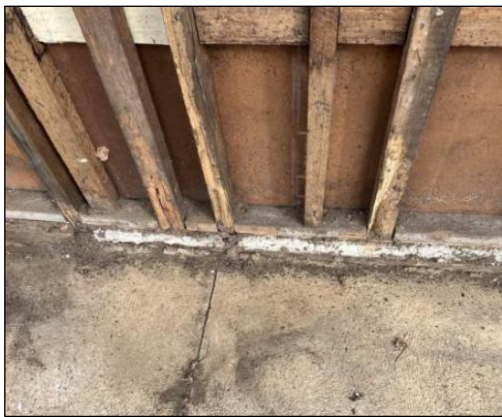
**Image 85. Detail of termite damage to north wall (Niche 2024).**

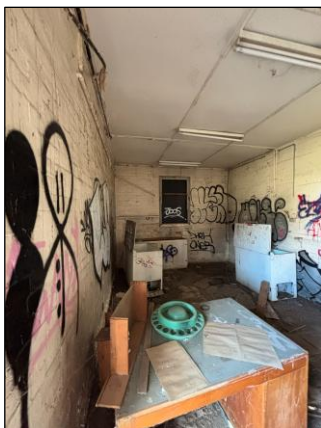
**Image 86. Ground floor interior looking south (Apr 26).**

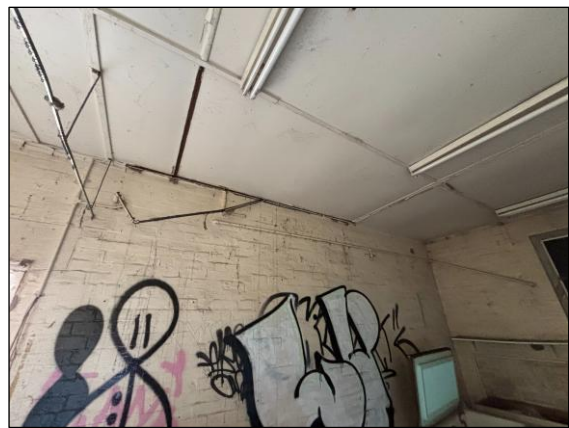
**Image 87. Damaged ceiling.**

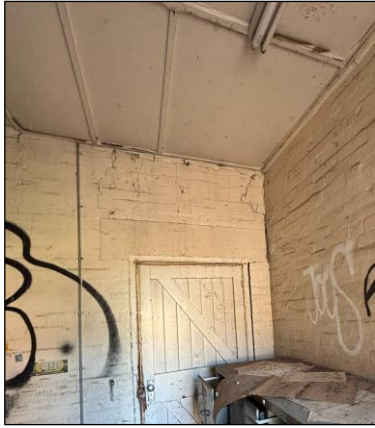
**Image 88. Damaged ceiling possibly from water ingress (Apr 26).**

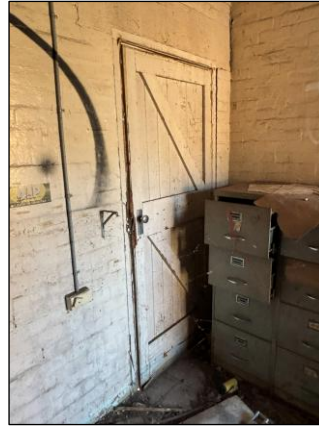
**Image 89. Termite damage to door and frame (Apr 26).**

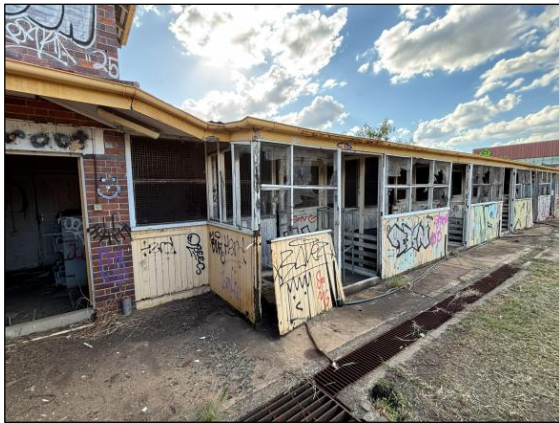
**Image 90. Dislodged and rot in timber (Apr 26).**

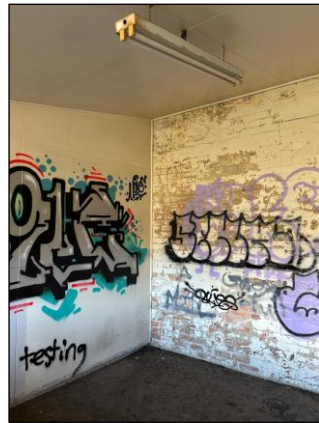
**Image 91. Asbestos wall and ceiling sheeting (Apr 26).**

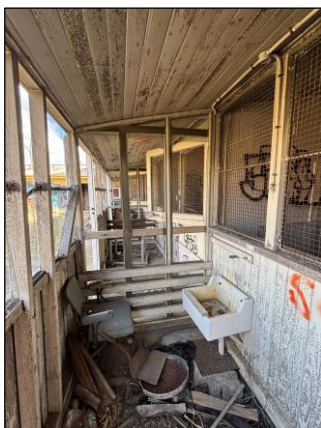
**Image 92. Damaged timber to entries (Apr 26).**

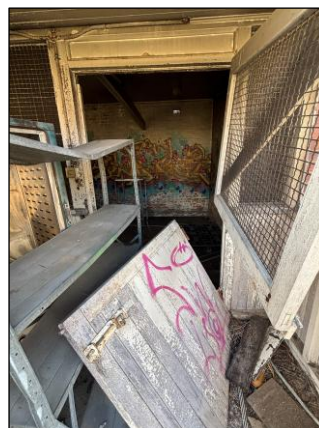
**Image 93. Dislodged door and furniture (Apr 26).**

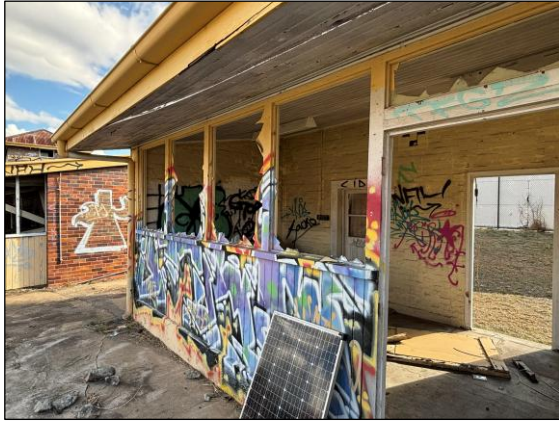
Image 94. Broken glass and removed door (Apr 26).

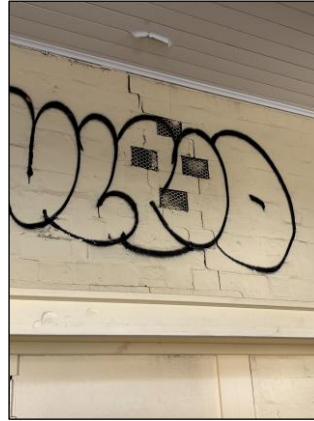
Image 95. Cracks in brickwork (Apr 26).

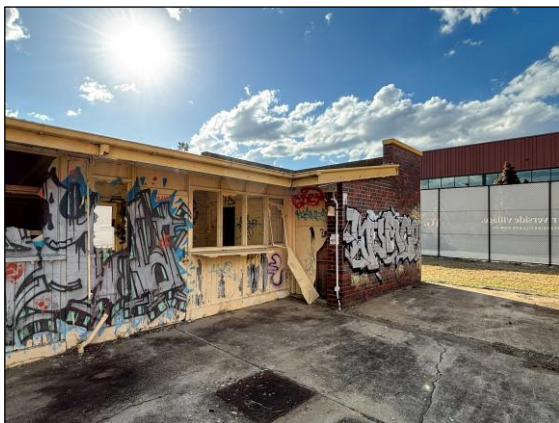
Image 96. Broken FC sheets (Apr 26).

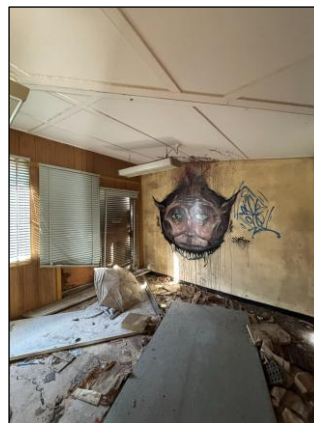
Image 97. Interior northern end with non-significant wall linings and aluminium glazed doors (Apr 26).

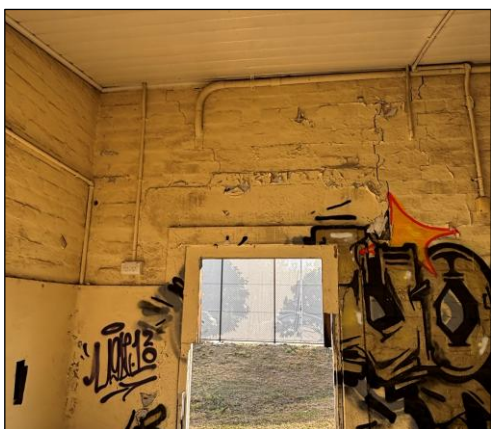
Image 98. Cracks in brickwork above doorway (Apr 26).

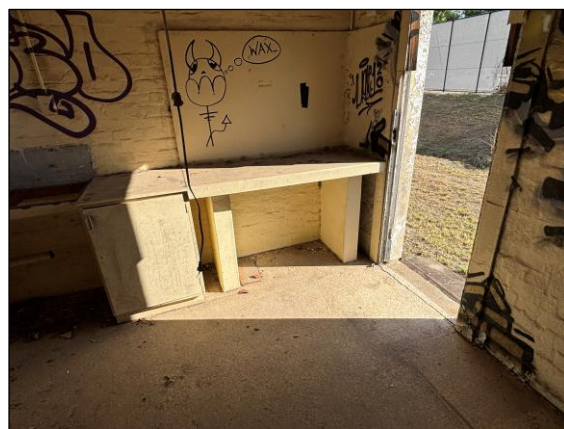
Image 99. Concrete workbench (Apr 26).

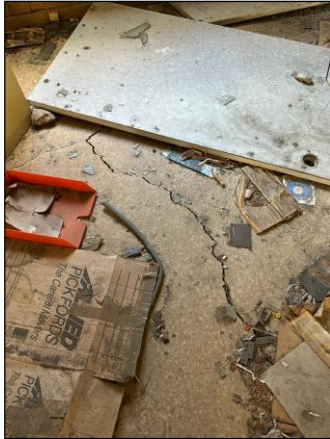
Image 100. Cracks in concrete floor (Apr 26).

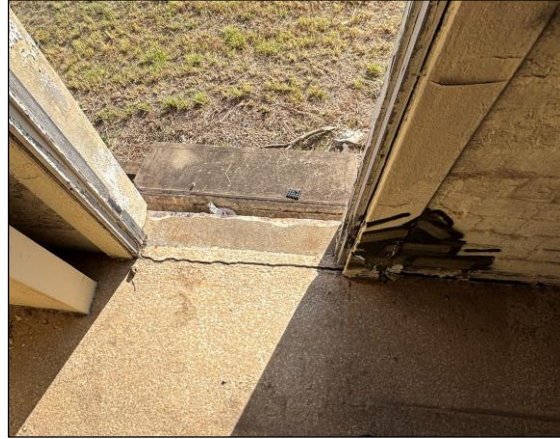
Image 101. Cracks in concrete floor (Apr 26).

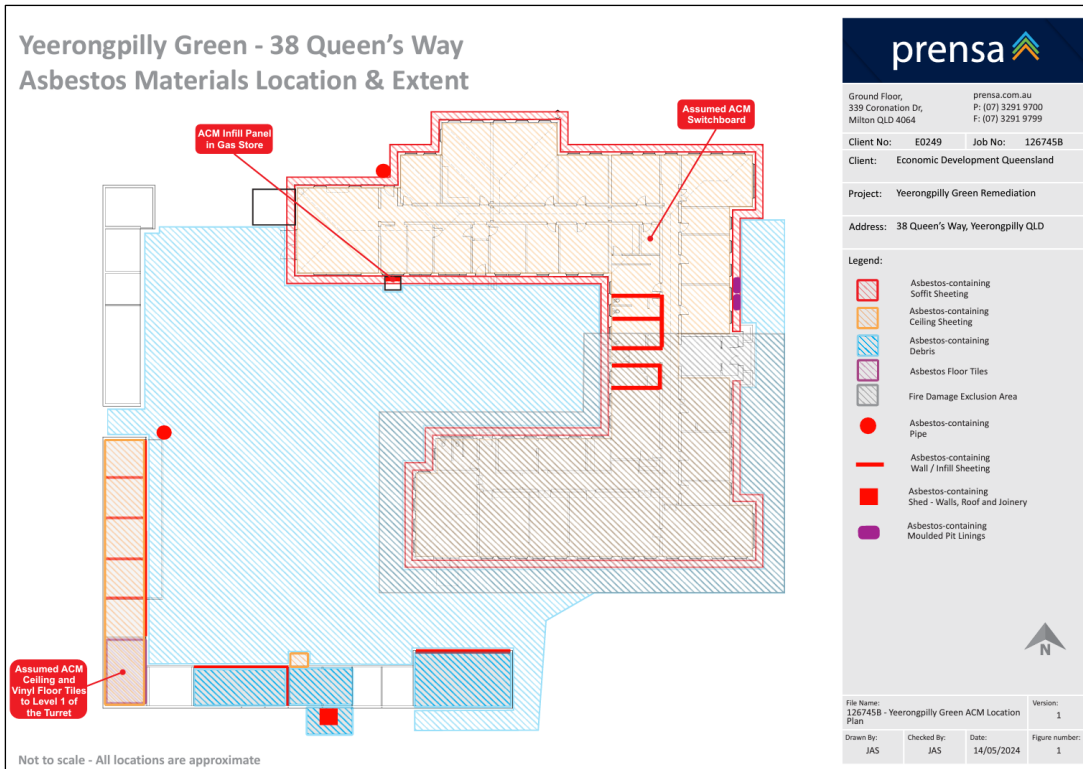
**Image 102. Site plan showing the location and extent of asbestos materials (Source: Prensa 126745B/1 in Niche 2024).**

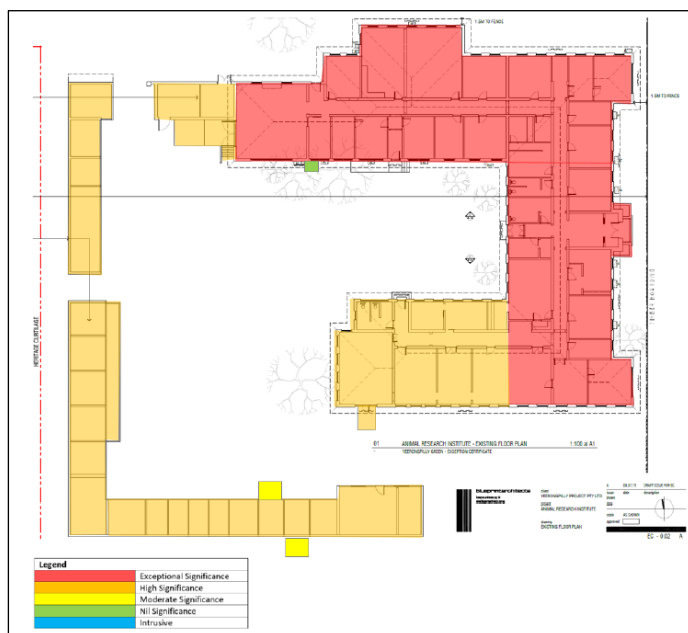
Image 104. Site Plan showing levels of significance (Source: Niche 2024).

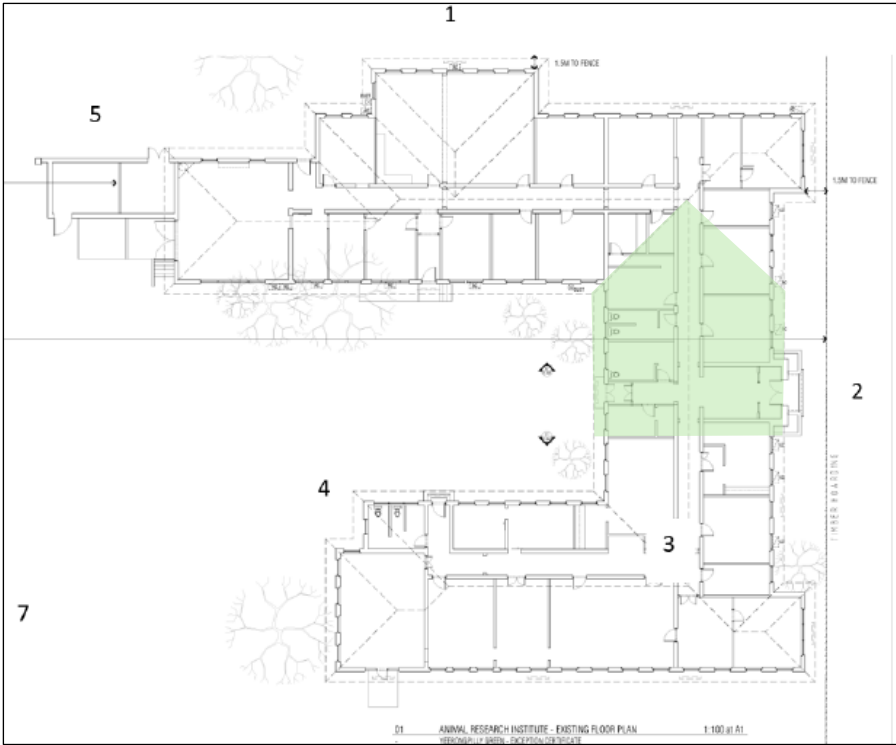
**Image 109. Repair roof framing to area of fire damage to be retained shaded in green (Source: Blueprint Architects from EDQ with shading by SAH).**

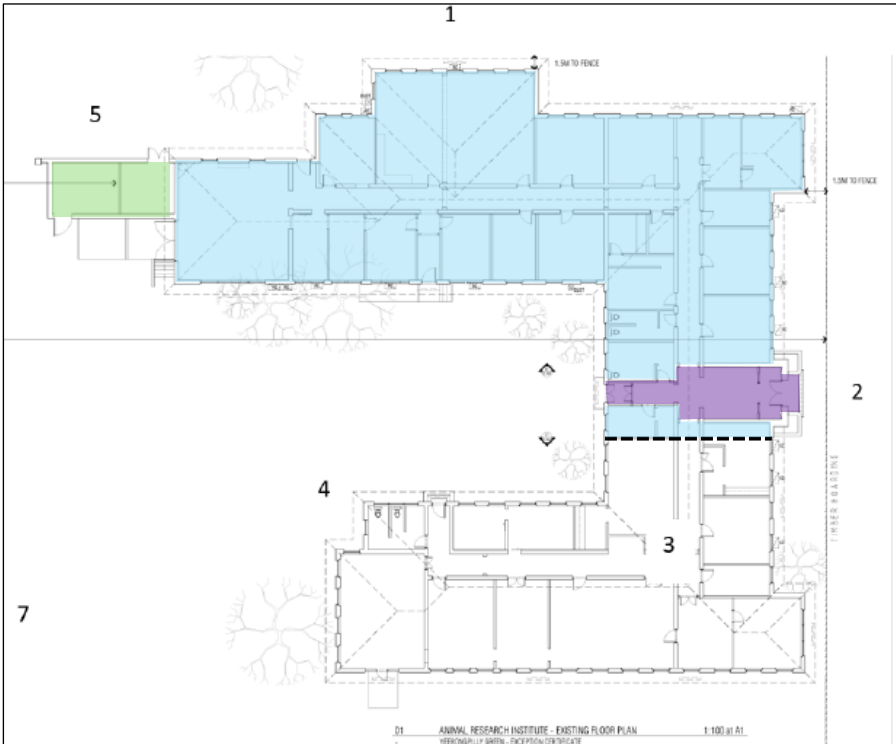
Legend	
	Plaster ceiling to be removed, leaving decorative plaster cornices in place if possible.
	Asbestos cement sheet ceiling with timber battens to be removed, leaving timber cornices in place if possible.
	Damaged asbestos cement sheet ceiling to be removed.

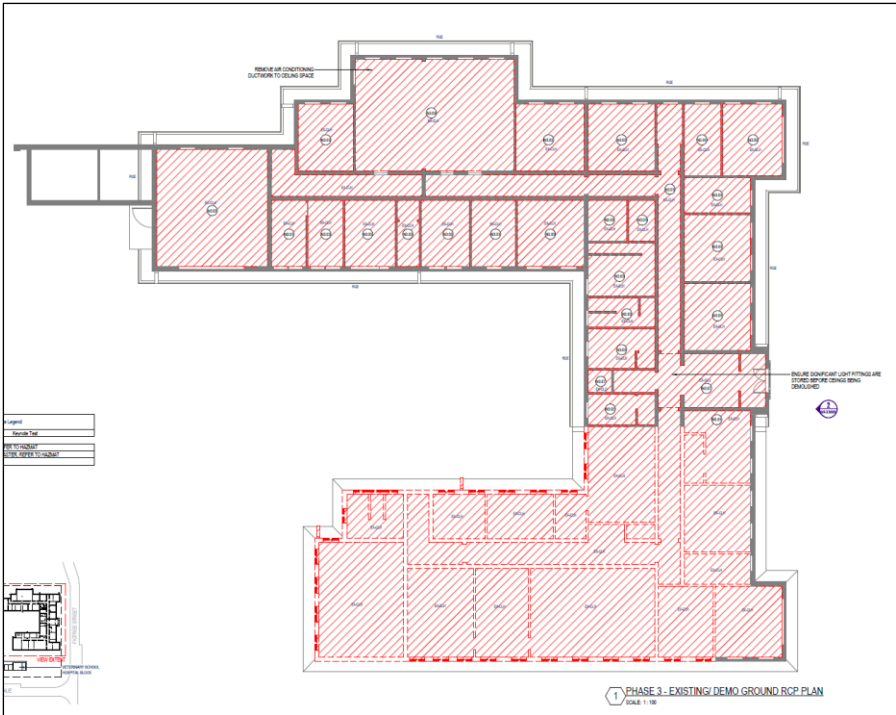
**Image 111. Reflected ceiling plan showing extent of ceiling to be demolished, with cornices to be retained if possible (Source: Architectus drawing AR-3.13000).**

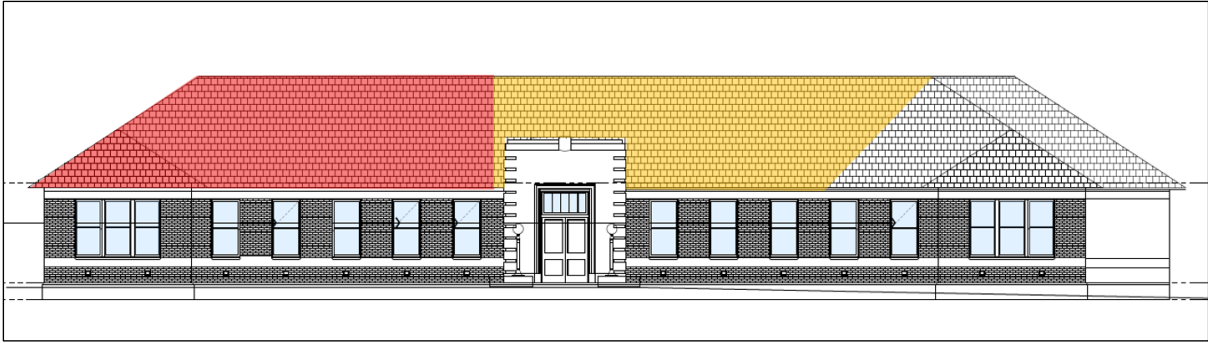
**Image 115. Main Building east elevation showing roof to be demolished and tiles salvaged in red and roof framing repaired with roof tiles reused in yellow (Source: Blueprint Architects from EDQ with shading by SAH).**

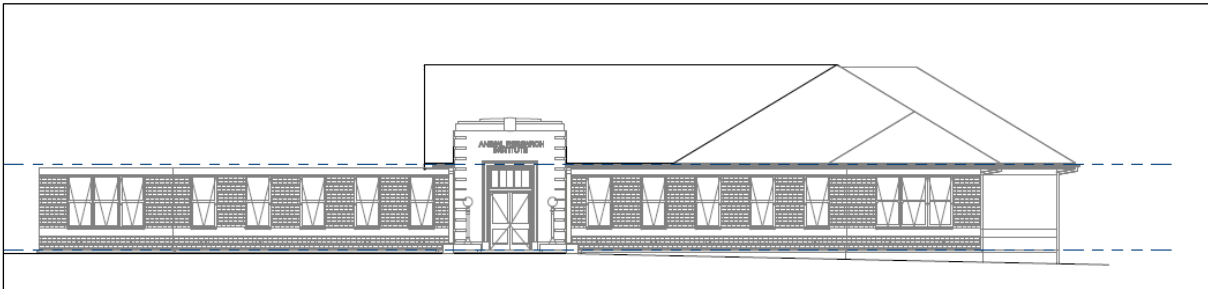
**Image 116. Main Building east elevation at completion of proposed works (Source: Architectus drawing AR-3.30000).**

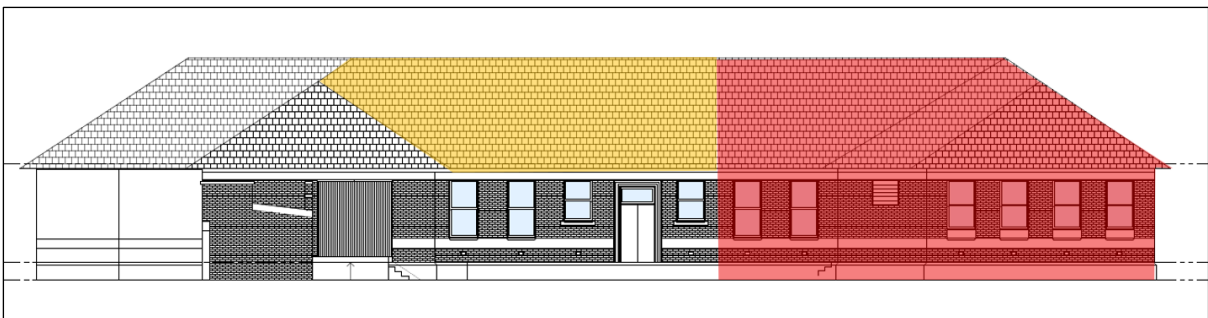
**Image 118. Main Building west elevation showing roof and building to be demolished and tiles salvaged in red and roof framing repaired with roof tiles reused in yellow (Source: Blueprint Architects from EDQ with shading by SAH).**

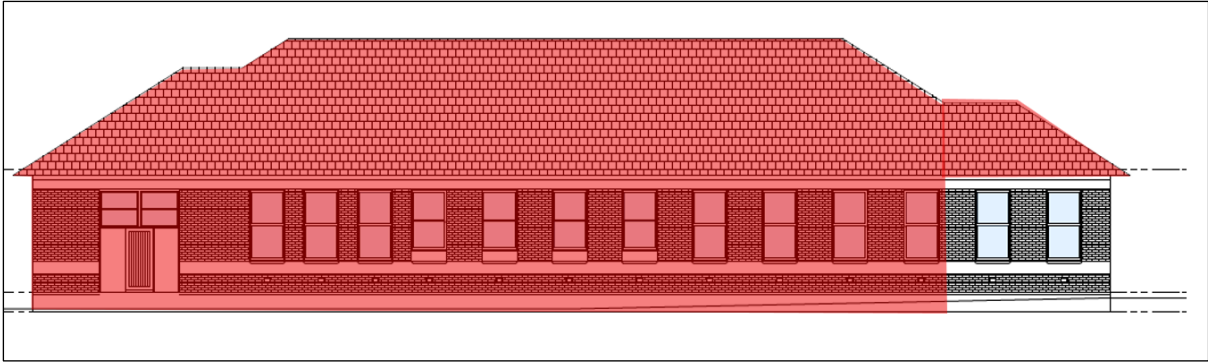
**Image 119. Main Building south elevation showing roof and building to be demolished and tiles salvaged in red (Source: Blueprint Architects from EDQ with shading by SAH).**

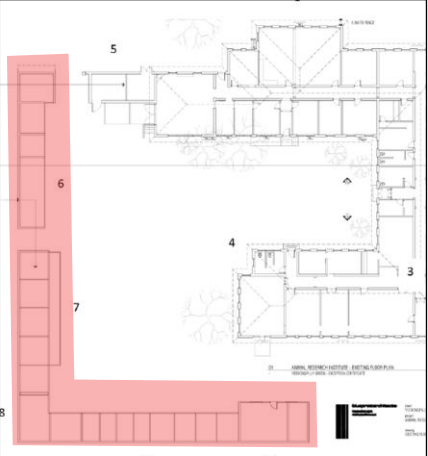
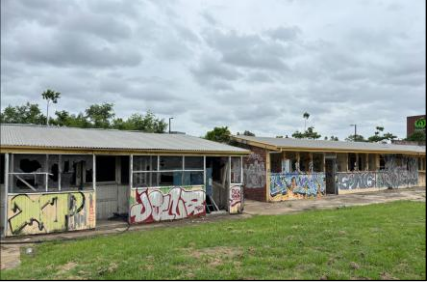
3.3	Roof tiles	Remove roof tiles to section to be demolished. Remove roof tiles to area damaged by fire.

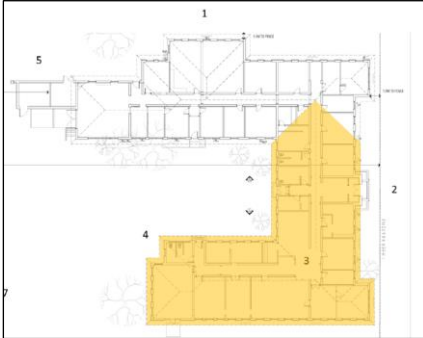
Store roof tiles on site for reuse for repairs to roof to be retained and for retiling of area damaged by fire once the roof framing has been repaired.
3.4	Roof framing	After inspections, remove the roof framing to the areas where the tiles have been removed.

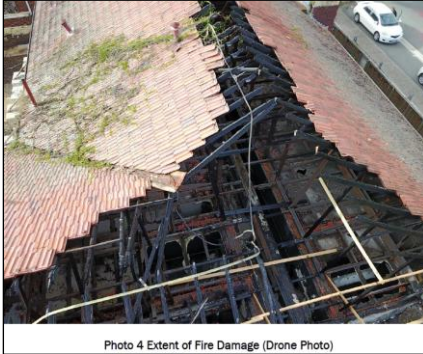
<p style="text-align: center; font-size: small;">Photo 4 Extent of Fire Damage (Drone Photo)</p>	Retain any joists and rafters in good condition for potential reuse. Retaining battens is not required.
3.5	South wing	Demolish south wing and southern end of east wing, retaining the eastern facade. Demolition includes removal of Hazmat materials.	<p style="text-align: center;"><b>Bligh Tanner</b></p>

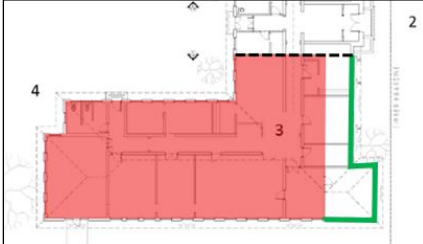
The retained facade (Shown in green) will need to be supported.

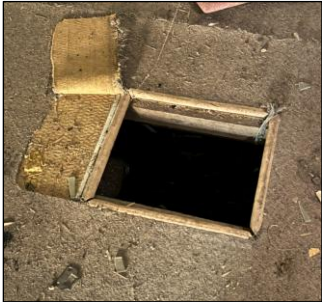
Investigations under the Exemption Certificate application are to enlarge existing manholes and confirm the extent of hazardous materials in the underfloor space and remove if possible. If the hazardous material cannot be removed from the openings created under the EC, all of the floorboards will need to be removed. <b>Carefully remove timber floorboards only if necessary.</b>

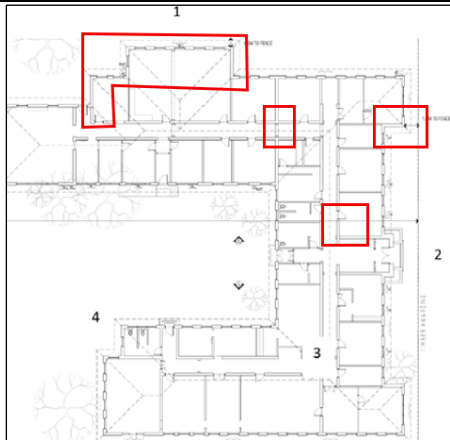
<p>To address the structural cracking, particularly in the northern side of the north wing.</p>
