# GRASS

Grazing Resilience and Sustainable Solutions

Action Plan for Land Management

# Action Plan for Land Management (Part 1)

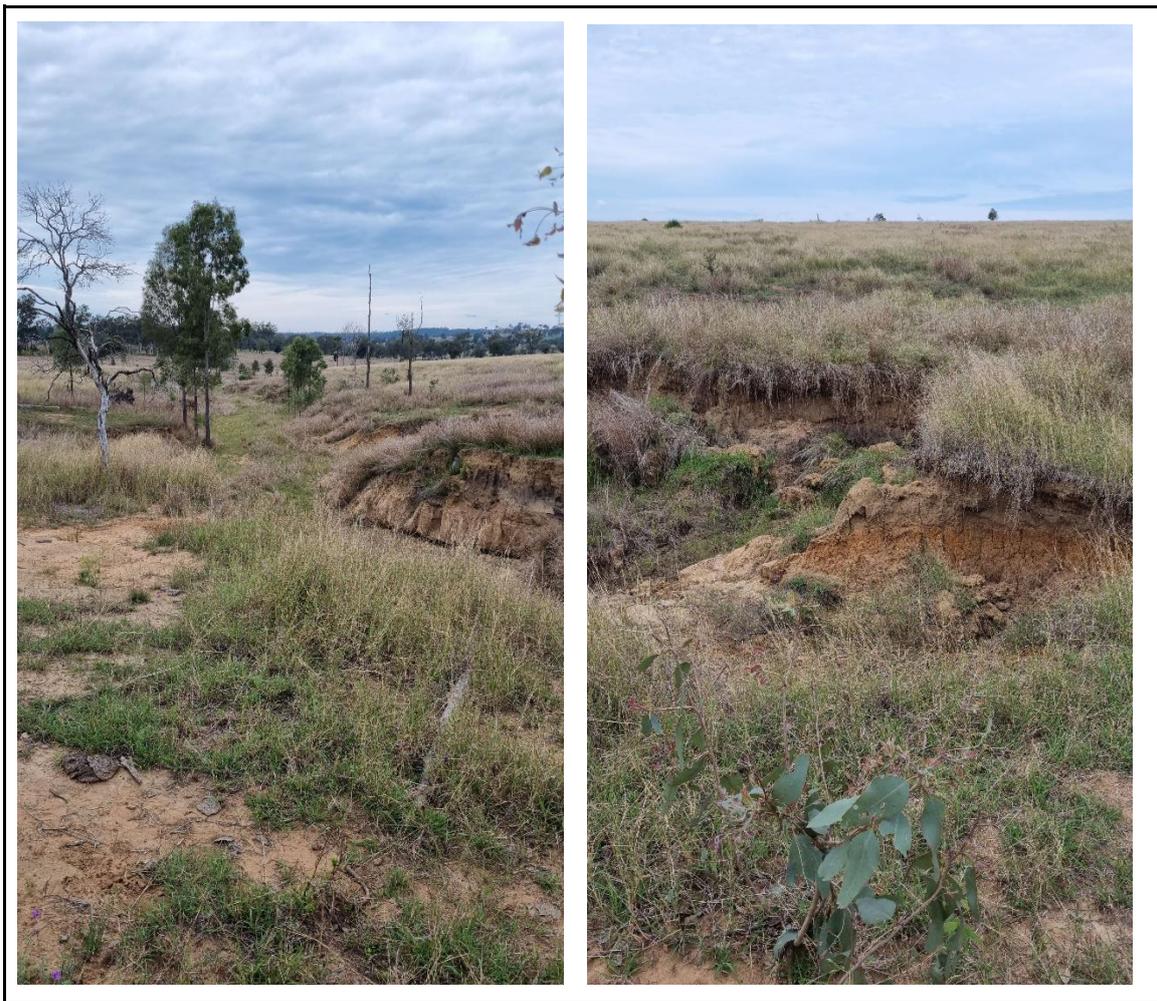
**Photos of area**

- Land type IB09 Gum-topped box country, with isolated canopy trees across the paddock with a very gentle incline.
- Ground cover of more than 70%, with the dominant pasture species being Creeping Blue Grass.
- The House paddock has a large grassed up gully with multiple active heads feeding the gully.
- Moderate soil erosion with exposed subsoil. Little to no visible cattle impact on gully or surrounds.

| Measures to improve land condition | Date measure/s implemented |
|--|---|
| <ul style="list-style-type: none"> <li>• Continue to maintain minimal grazing pressure and good ground cover in and around the erosion area.</li> <li>• Encourage any trees to emerge surrounding the gully area.</li> <li>• Contour/ pondage banks may be required to hold water above the gully, alleviating pressure, and encourage the dispersal of water over a larger surface area.</li> <li>• In areas of low or no ground cover, nutrients such as hay or mulch may be required to promote growth.</li> <li>• Woody debris might be needed to help accumulate soil.</li> </ul> | |

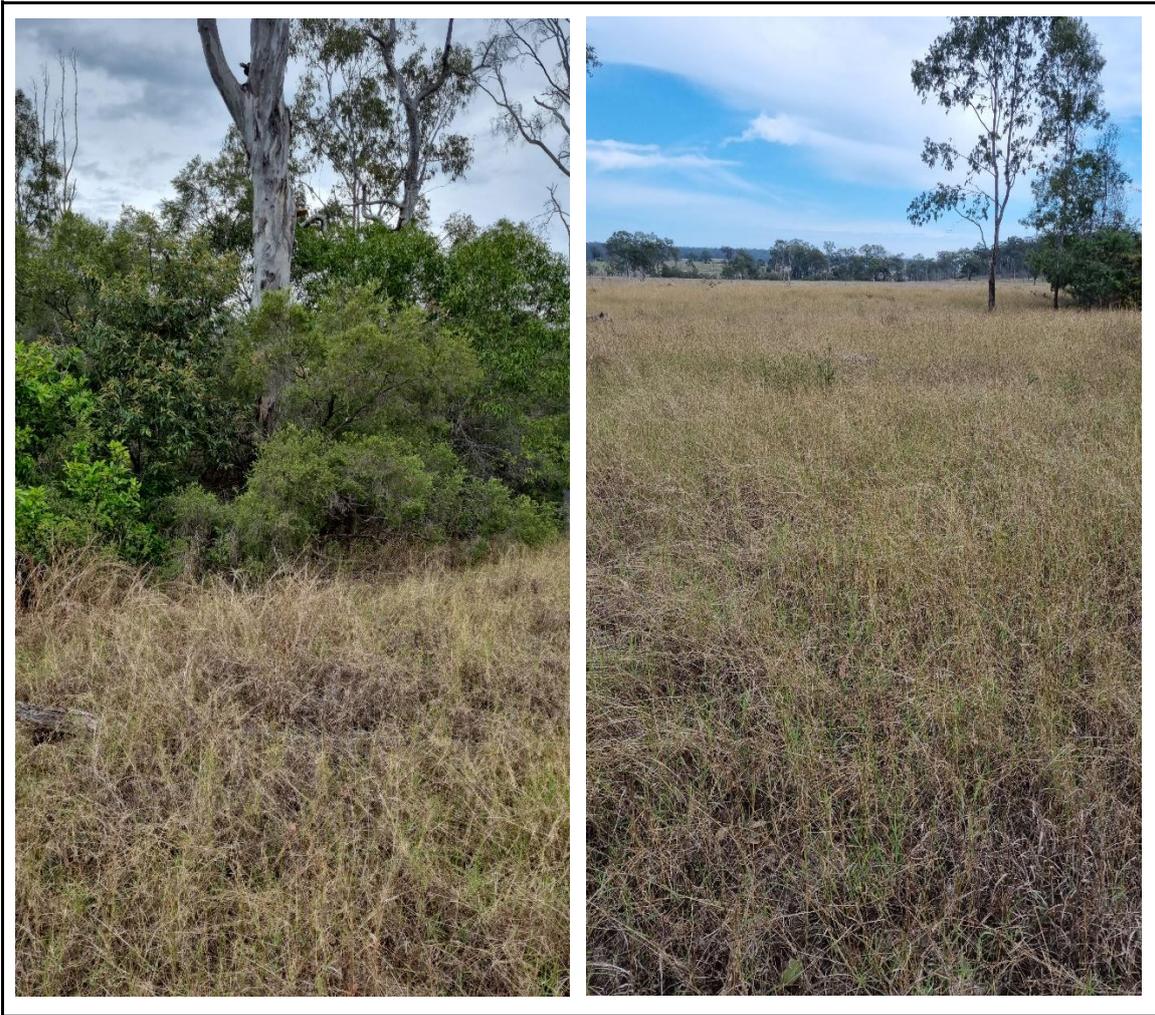
**Photos of area**

- Land type IB09 Gum-topped box country, with isolated canopy trees across the paddock with a very gentle incline.
- Ground cover of more than 70%, with the dominant pasture species being Creeping Blue Grass.
- Well vegetated riparian buffer zone along the creek. Mid-dense understory and canopy species present.
- Low to no erosion and cattle impacts visible in assessment area.

| <ul style="list-style-type: none"> <li>• Continue effective rotational management of the Bore paddock.</li> <li>• Monitor early signs of cattle impact on riparian area.</li> </ul> | |

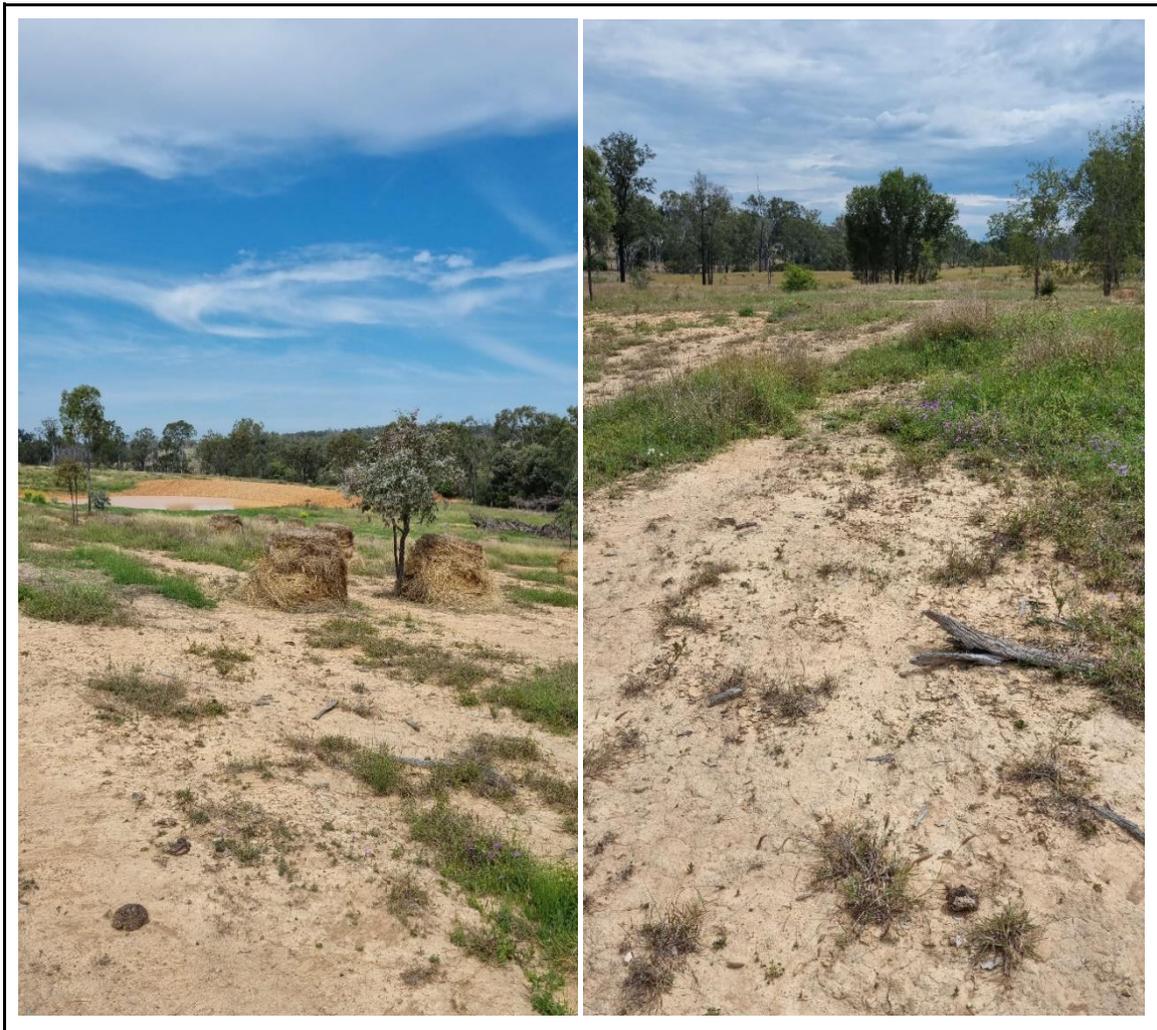
**Photos of area**

- Identified area of 50 – 70% groundcover. Remediation work have been undertaken by landholder to slow the flow of water & encourage ground cover by spreading nutrients across the site in the form of bales of hay. This has been successful in introducing vegetation back into the landscape & helping retain soil.
- A large dam has been constructed to catch and hold water as it travels down the slope. Some minor erosion has occurred above dam from rain event occurring just after construction.
- Land type IB09 Gum topped box, isolated canopy trees across paddock.

| <ul style="list-style-type: none"> <li>• Continue efforts to return nutrients to the soil, promoting vegetation cover by means of hay bales. Especially around dam area. Contour bank horizontally across the slope will help slow and retain moisture in the landscape, preventing soil movement.</li> <li>• Strategically resting paddocks allows most desirable species time to regenerate. Aim to rest pastures in both the wet and the dry season</li> <li>• Pasture budget at the end of the wet season and match carrying capacity (feed available) to stocking rate</li> </ul> | |

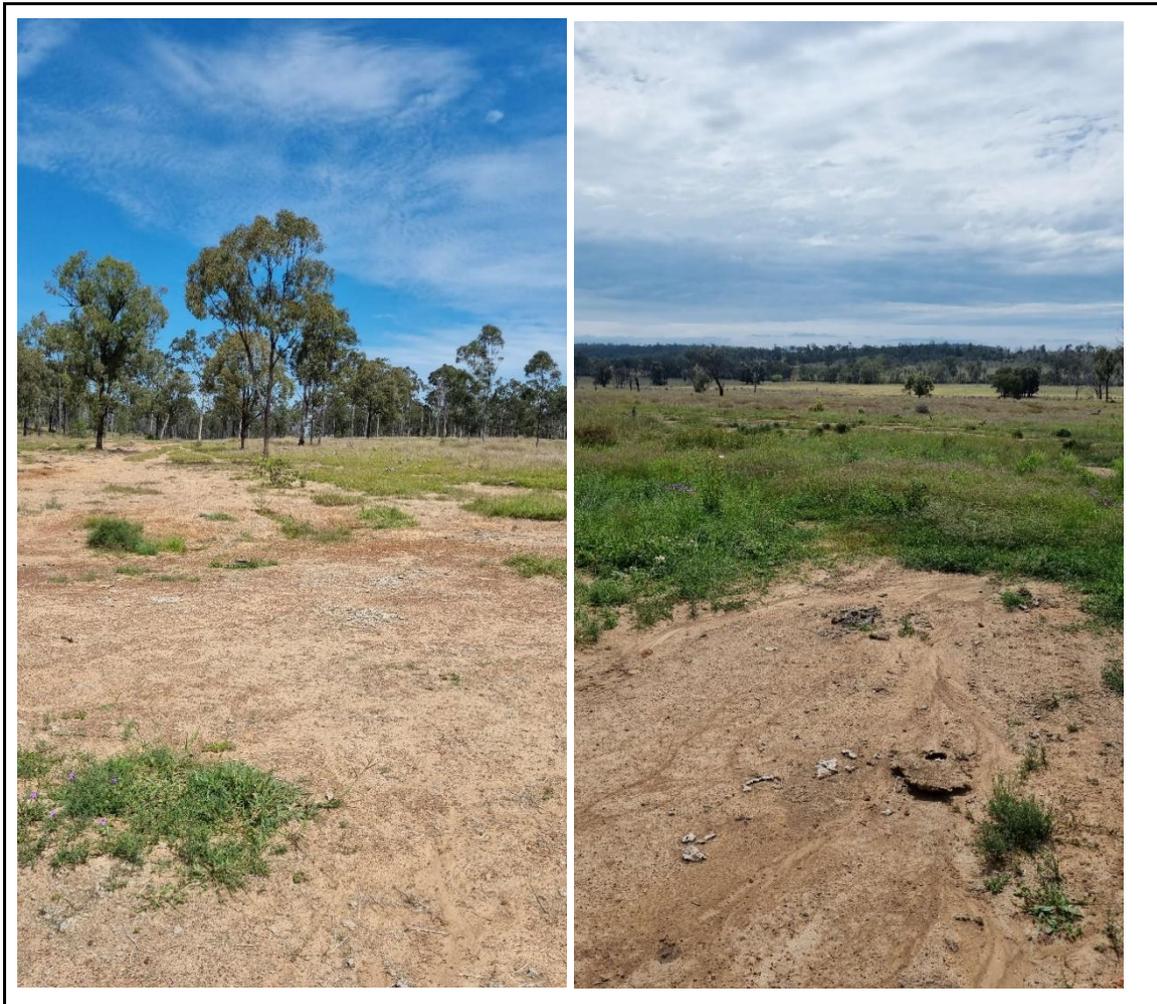
**Photos of area**

- Land type IB19 Spotted gum ridges. Pasture deficit due to African Love grass being the dominant pasture species with reduced biomass.
- Ground cover across the paddock is 50-70%, with some areas really lacking cover in the drainage area.
- Canopy trees scatter the landscape, particularly *Corymbia citriodora* & *Eucalyptus crebra*

| <ul style="list-style-type: none"> <li>• Graze heavily while young and succulent when African lovegrass is most palatable and nutritious to stock. Consider re-sowing desirable pasture species in small areas that are heavily infested with African love grass.</li> <li>• In areas of low or no ground cover, nutrients such as hay or mulch may be required to promote growth. Small contour banks or whoa-boys may be required to prevent further erosion on bare surfaces/ tracks.</li> <li>• Strategically resting paddocks allows most desirable species time to regenerate. Aim to rest pastures</li> </ul> | |

in both the wet and the dry season. Pasture budget at the end of the wet season and match carrying capacity (feed available) to stocking rate

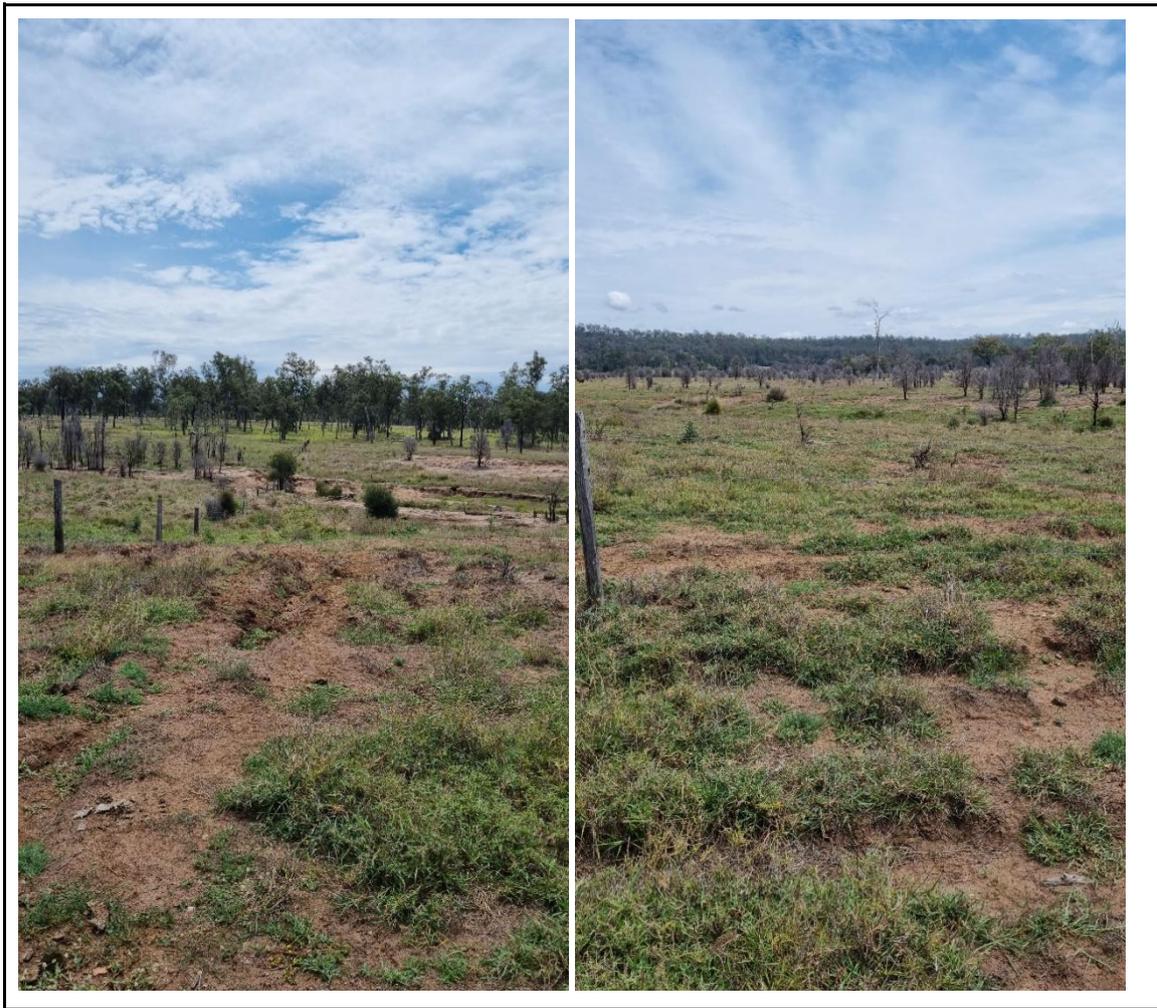
**Photos of area**

- IB09 Gum topped box country, with one of the predominant pasture species being Buffel grass. Overall ground cover across the paddock exceeded 70%.
- The gully area showed signs of erosion and bare surfaces, with little to no canopy trees on the flats. Tree density increased with elevation.
- Moderate soil erosion with exposed subsoil. Little to no visible cattle impact on gully or surrounds.

| <ul style="list-style-type: none"> <li>• Encourage any vegetation to grow in and around this gully area. Intervention may be needed to encourage vegetation growth and prevent soil loss.</li> <li>• In areas of low or no ground cover, nutrients such as hay or mulch may be required to promote growth. Small contour banks or whoa bouys may be required to prevent further erosion on bare surfaces.</li> <li>• Strategically resting paddocks allows most desirable species time to regenerate. Aim to rest pastures in both the wet and the dry season</li> <li>• Pasture budget at the end of the wet season and match carrying capacity (feed available) to stocking rate</li> </ul> | |

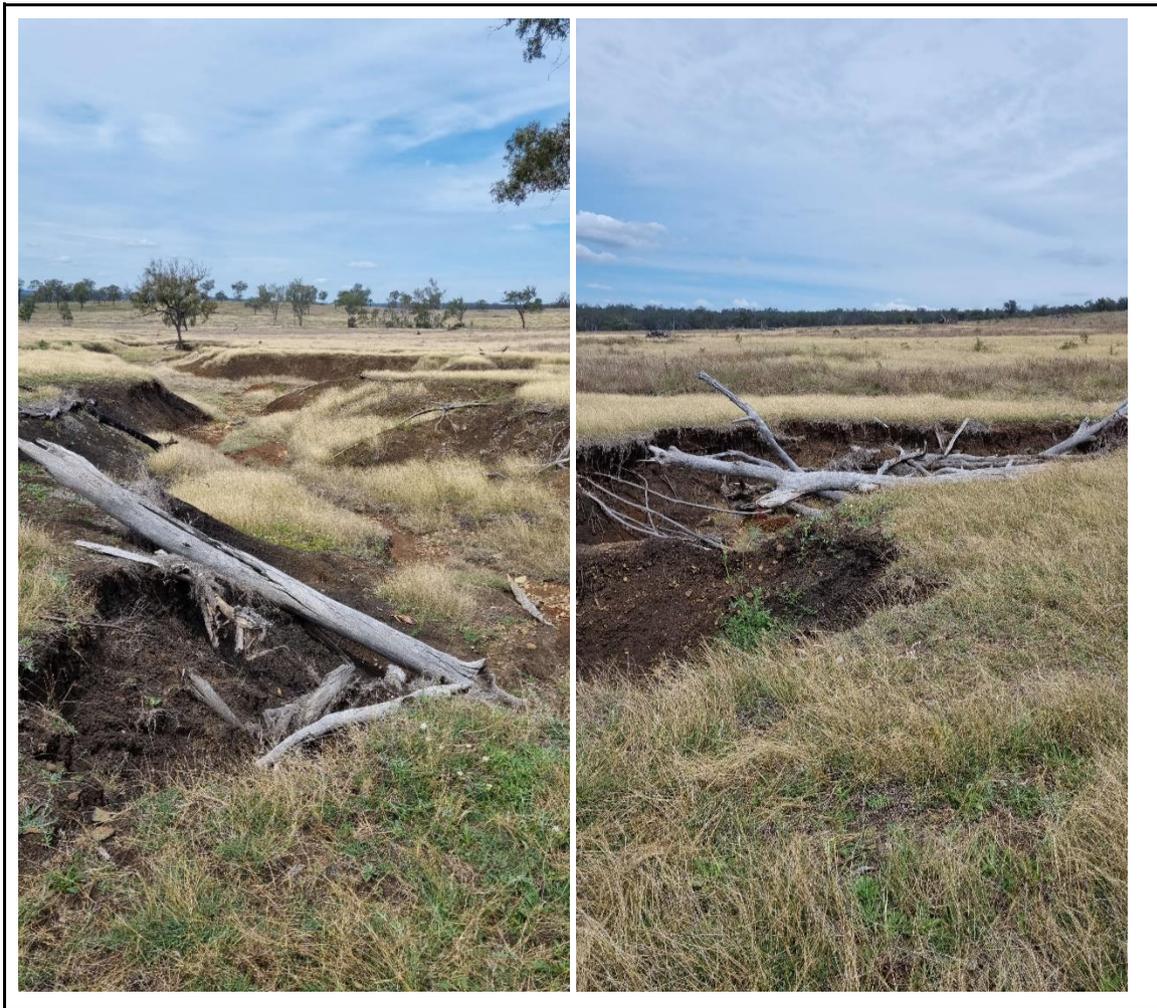
**Photos of area**

- Land type IB14 Narrow leaved ironbark on granite. Pasture deficit due to African Love grass being the dominant pasture species.
- Ground cover of more than 70%, with the dominant pasture species being Creeping Blue Grass.
- The Plaine paddock has a large grassed up gully with multiple active heads feeding the gully.
- Moderate soil erosion with exposed subsoil. Little to no visible cattle impact on gully or surrounds.

| <ul style="list-style-type: none"> <li>• Continue to maintain minimal grazing pressure and good ground cover in and around the erosion area. Encourage any trees to emerge surrounding the gully area.</li> <li>• Contour/ pondage banks may be required to hold water above the gully, alleviating pressure, and encourage the dispersal of water over a larger surface area.</li> <li>• In areas of low or no ground cover, nutrients such as hay or mulch may be required to promote growth.</li> <li>• Graze heavily while young and succulent when African lovegrass is most palatable and nutritious to stock. Consider re-sowing desirable pasture species.</li> </ul> | |
