## What causes streambed erosion?

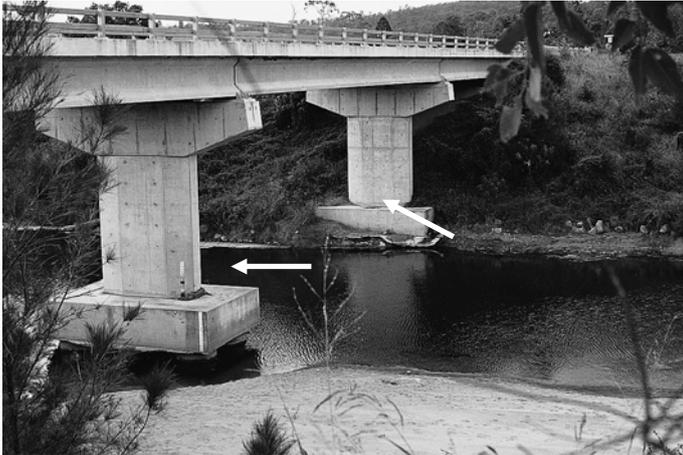
These bridge abutments were originally built at bed level

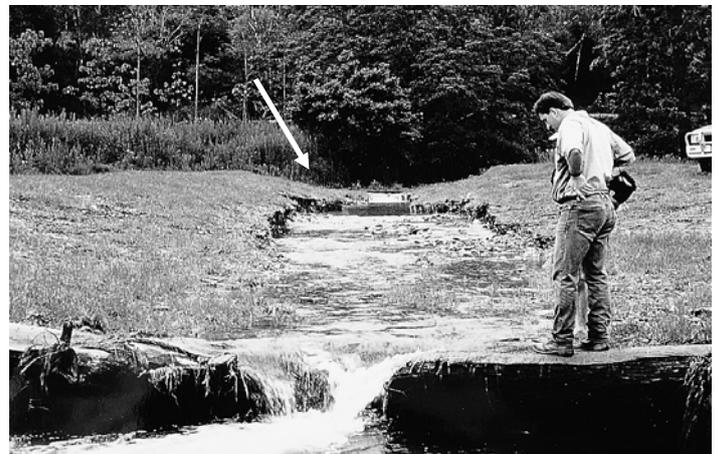
A 'headcut' or 'nick point' can indicate active bed erosion

Bed lowering can move in both an upstream direction (as a 'headcut' or 'nick point') and/or downstream, influencing channel stability over an extensive length of the river or stream system.
